Research article

## Pedestrian injury and the built environment: an environmental scan of hotspots

BMC Public Health 2009, 9:233 doi:10.1186/1471-2458-9-233

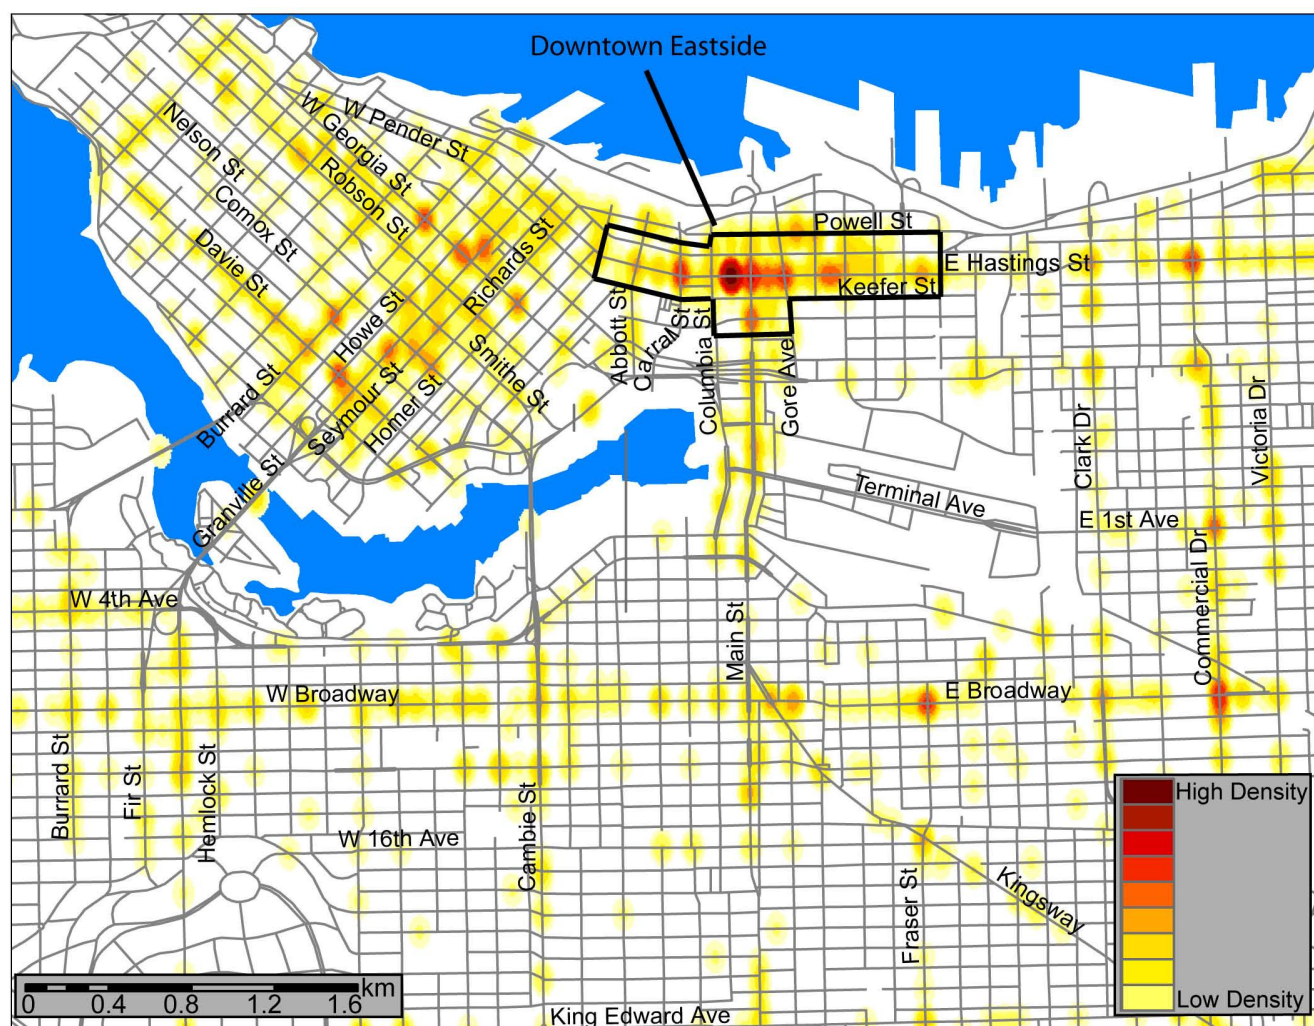
**Figure 1**  
**The intersections and midblock locations where pedestrian injuries were recorded, illuminating the high density locations.**

A total of 2358 pedestrian-vehicle collisions were recorded within the City of Vancouver over the 6 year period, for an average annual pedestrian injury incidence rate of 66.6/100,000 residents. Intersections – rather than midblock locations – accounted for 61% of all incidents. Our analysis highlighted 32 pedestrian injury hotspot locations in the City of Vancouver for this time period. Figure 1 shows the intersections and midblock locations where pedestrian injuries were recorded and illuminates the high density locations. The darkest shades indicate the higher density hotspots. Of the 32 hotspots, 21 (66%) were at intersections while 11 were at midblock locations. Thirty-one of 32 hotspots were situated on either major collector or major arterial roads, with just one at a midblock location of a minor traffic-restricted street. Overall, most hotspots were located on downtown streets. The downtown eastside (DTES) area was particularly highlighted as an area with multiple high-incident locations, including the 2 highest ranked pedestrian injury hotspots.

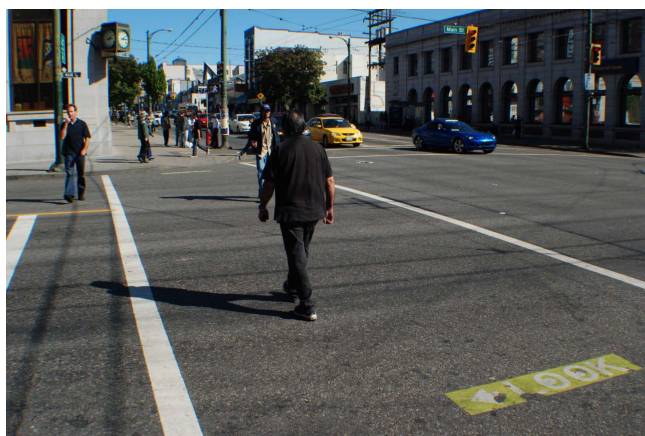
**Figure 2**  
**Intersection at Hastings and Main Streets.**

streets and a slight reduction in vehicle speeds [31]. Implementation of medians or refuge islands is likely possible at many of the hotspot locations in which they are absent. The highest-ranked intersection location at Hastings and Main Streets (Figure 2) is a good candidate for installation of a roadway-dividing median which will allow for a two stage crossing if needed, and will likely reduce vehicle speeds in this pedestrian-congested area. Another roadway modification designed with the pedestrian in mind (and endorsed by the City of Vancouver) is corner sidewalk bulges to reduce crossing times for pedestrians [32]. Figure 3 shows a location with a corner bulge in place. Medians and bulges at this hotspot location may require lane narrowing, or a possible lane removal which may result in reduced vehicle flow on this thoroughfare; however, the potential to increase pedestrian safety at this high-incident location should be paramount.

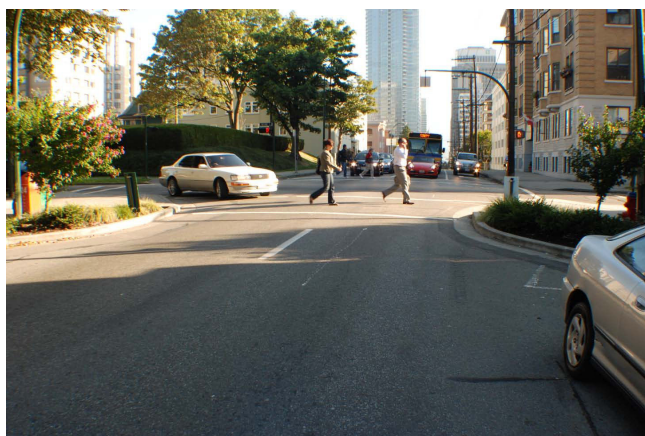
**Figure 3**  
**A location with a corner bulge in place.**

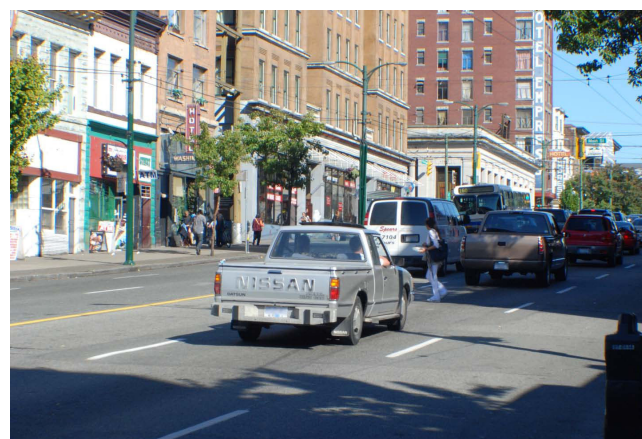
**Figure 4**  
**The midblock location on Hastings St. between Columbia and Main.**

The absence of marked and signalized pedestrian crossings at all but one midblock location is of particular concern. Well-marked crosswalks with a pedestrian-controlled signal can reduce pedestrian-vehicle conflicts [33]. Another option that has been shown to be effective at midblock locations are non-signalized crosswalks with in-pavement lights that flash when a pedestrian is present [34]. These were not present at any of our hotspot locations. The midblock location on Hastings St. between Columbia and Main was by far the highest ranked incident location (Figure 4). This is one of the main areas of the DTES where large groups of homeless people congregate, and is also the precise location of Insite, the government-sponsored controlled safe drug injection facility. These are likely factors in the disproportionately large number of pedestrian-vehicle collisions at this location; however, no crosswalk, traffic-calming measures, or pedestrian safety interventions are in place at this mid-

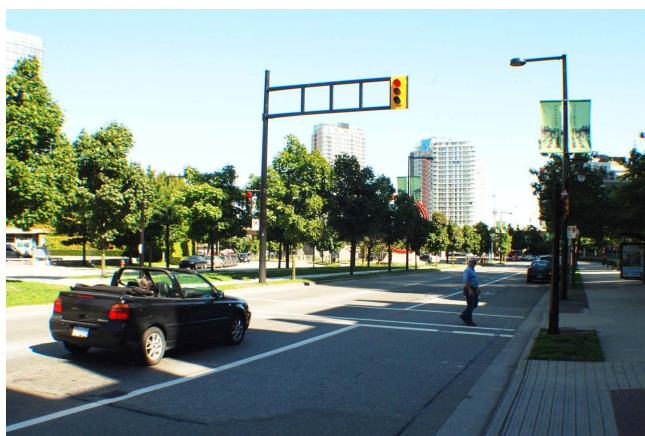
**Figure 5**  
**A signalized crosswalk and median at a midblock location on Expo/Pacific Blvd.**

block location. The City of Vancouver has committed to providing midblock crossings on downtown streets near "significant pedestrian generators that create high demands for pedestrian crossing at mid-block" [32]. Figure 5 shows a signalized crosswalk and median at a mid-block location on Expo/Pacific Blvd. This type of roadway design/traffic calming measure could potentially improve pedestrian safety at this very high-incident location on Hastings St. Indeed, this study is the basis for concerted and directed intervention on the part of public safety officials. Moreover, it provides a protocol for determining and studying hotspot locations in other cities.
